## Statement of Historic Significance

**Minehead Old Hospital  
The Parade  
Minehead  
Somerset**

**on behalf of  
Minehead Old Town Hall Investments Ltd**

**APPENDIX A**  
**HISTORIC DEVELOPMENT PLANS**

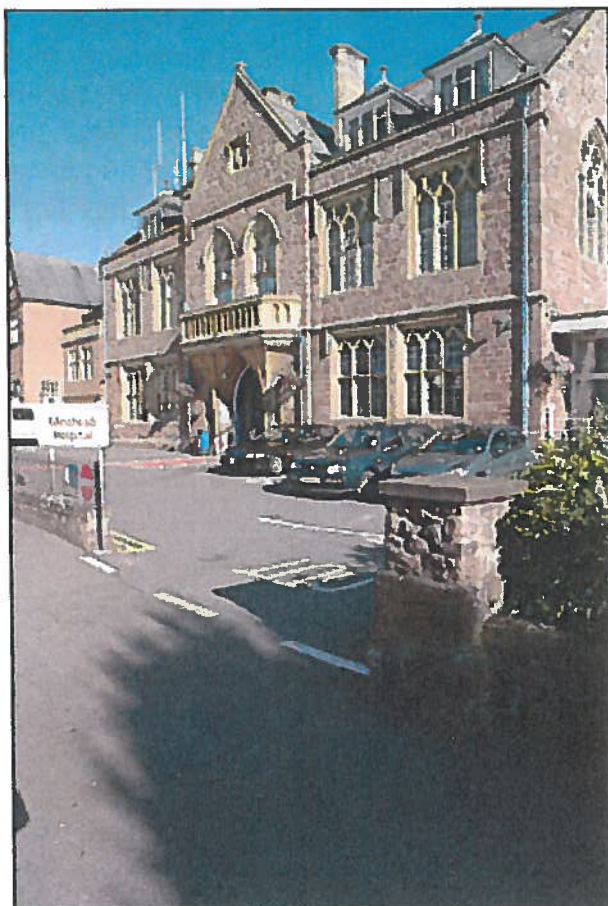
IoE Number:	391248
Location:	MINEHEAD HOSPITAL, THE PARADE (north side) MINEHEAD, WEST SOMERSET, SOMERSET
Photographer:	Mr R.M Rayner
Date Photographed:	16 July 2001
Date listed:	30 September 1994
Date of last amendment:	30 September 1994
Grade	II

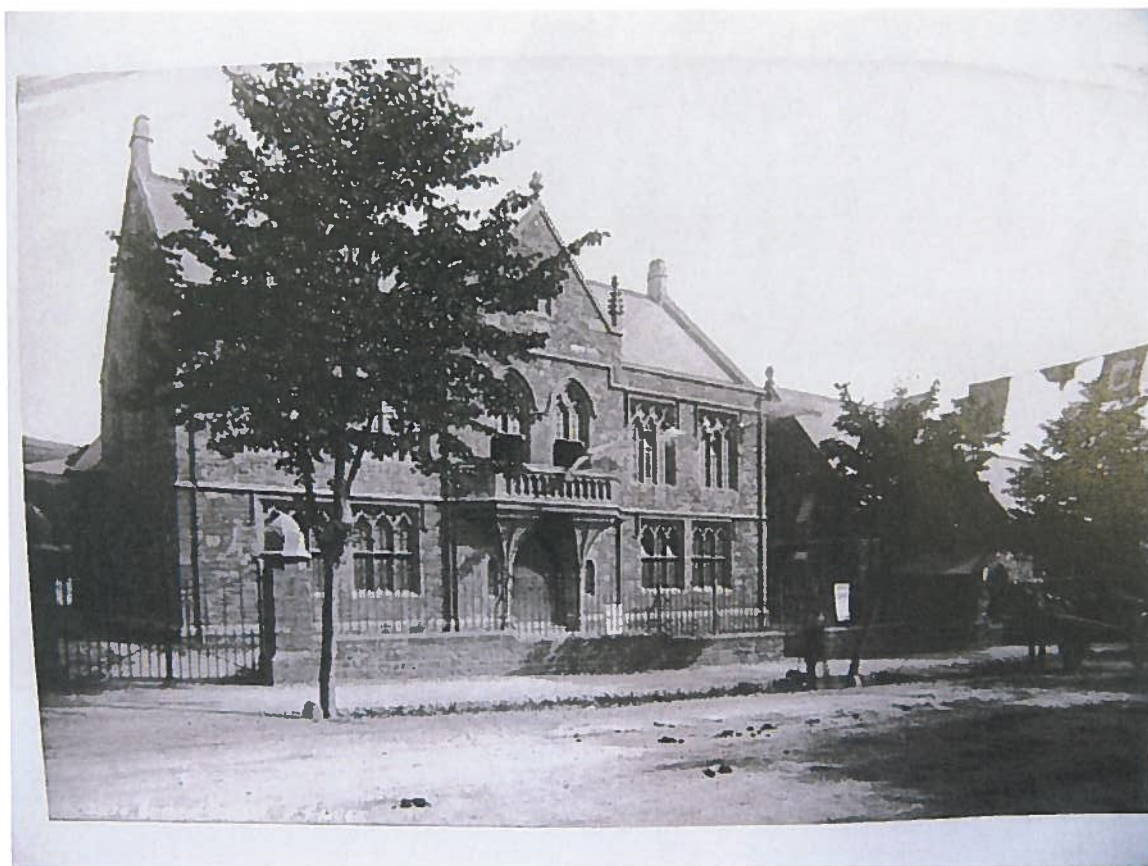
c 1889

- i. Photograph taken circa 1890 of front of building as originally built complete with iron gates and railings along the front wall. The front roof slope is devoid of dormers and it is possible to see along the east gable to the eaves of the rear roof, extending down from the rear gable projection which was converted post 1910 into the hospital operating theatre prior to the later two storey wing extension. A rather grainy photograph taken from North Hill shows this to be the case.
- ii. Archive photograph circa 1920 described as 'The Hospital, Minehead' showing the front elevation with the 4 no. dormers and 2 central chimney stacks in place post 1910 Bank alterations. The iron railings and gate posts are still retained fronting on to the pavement.

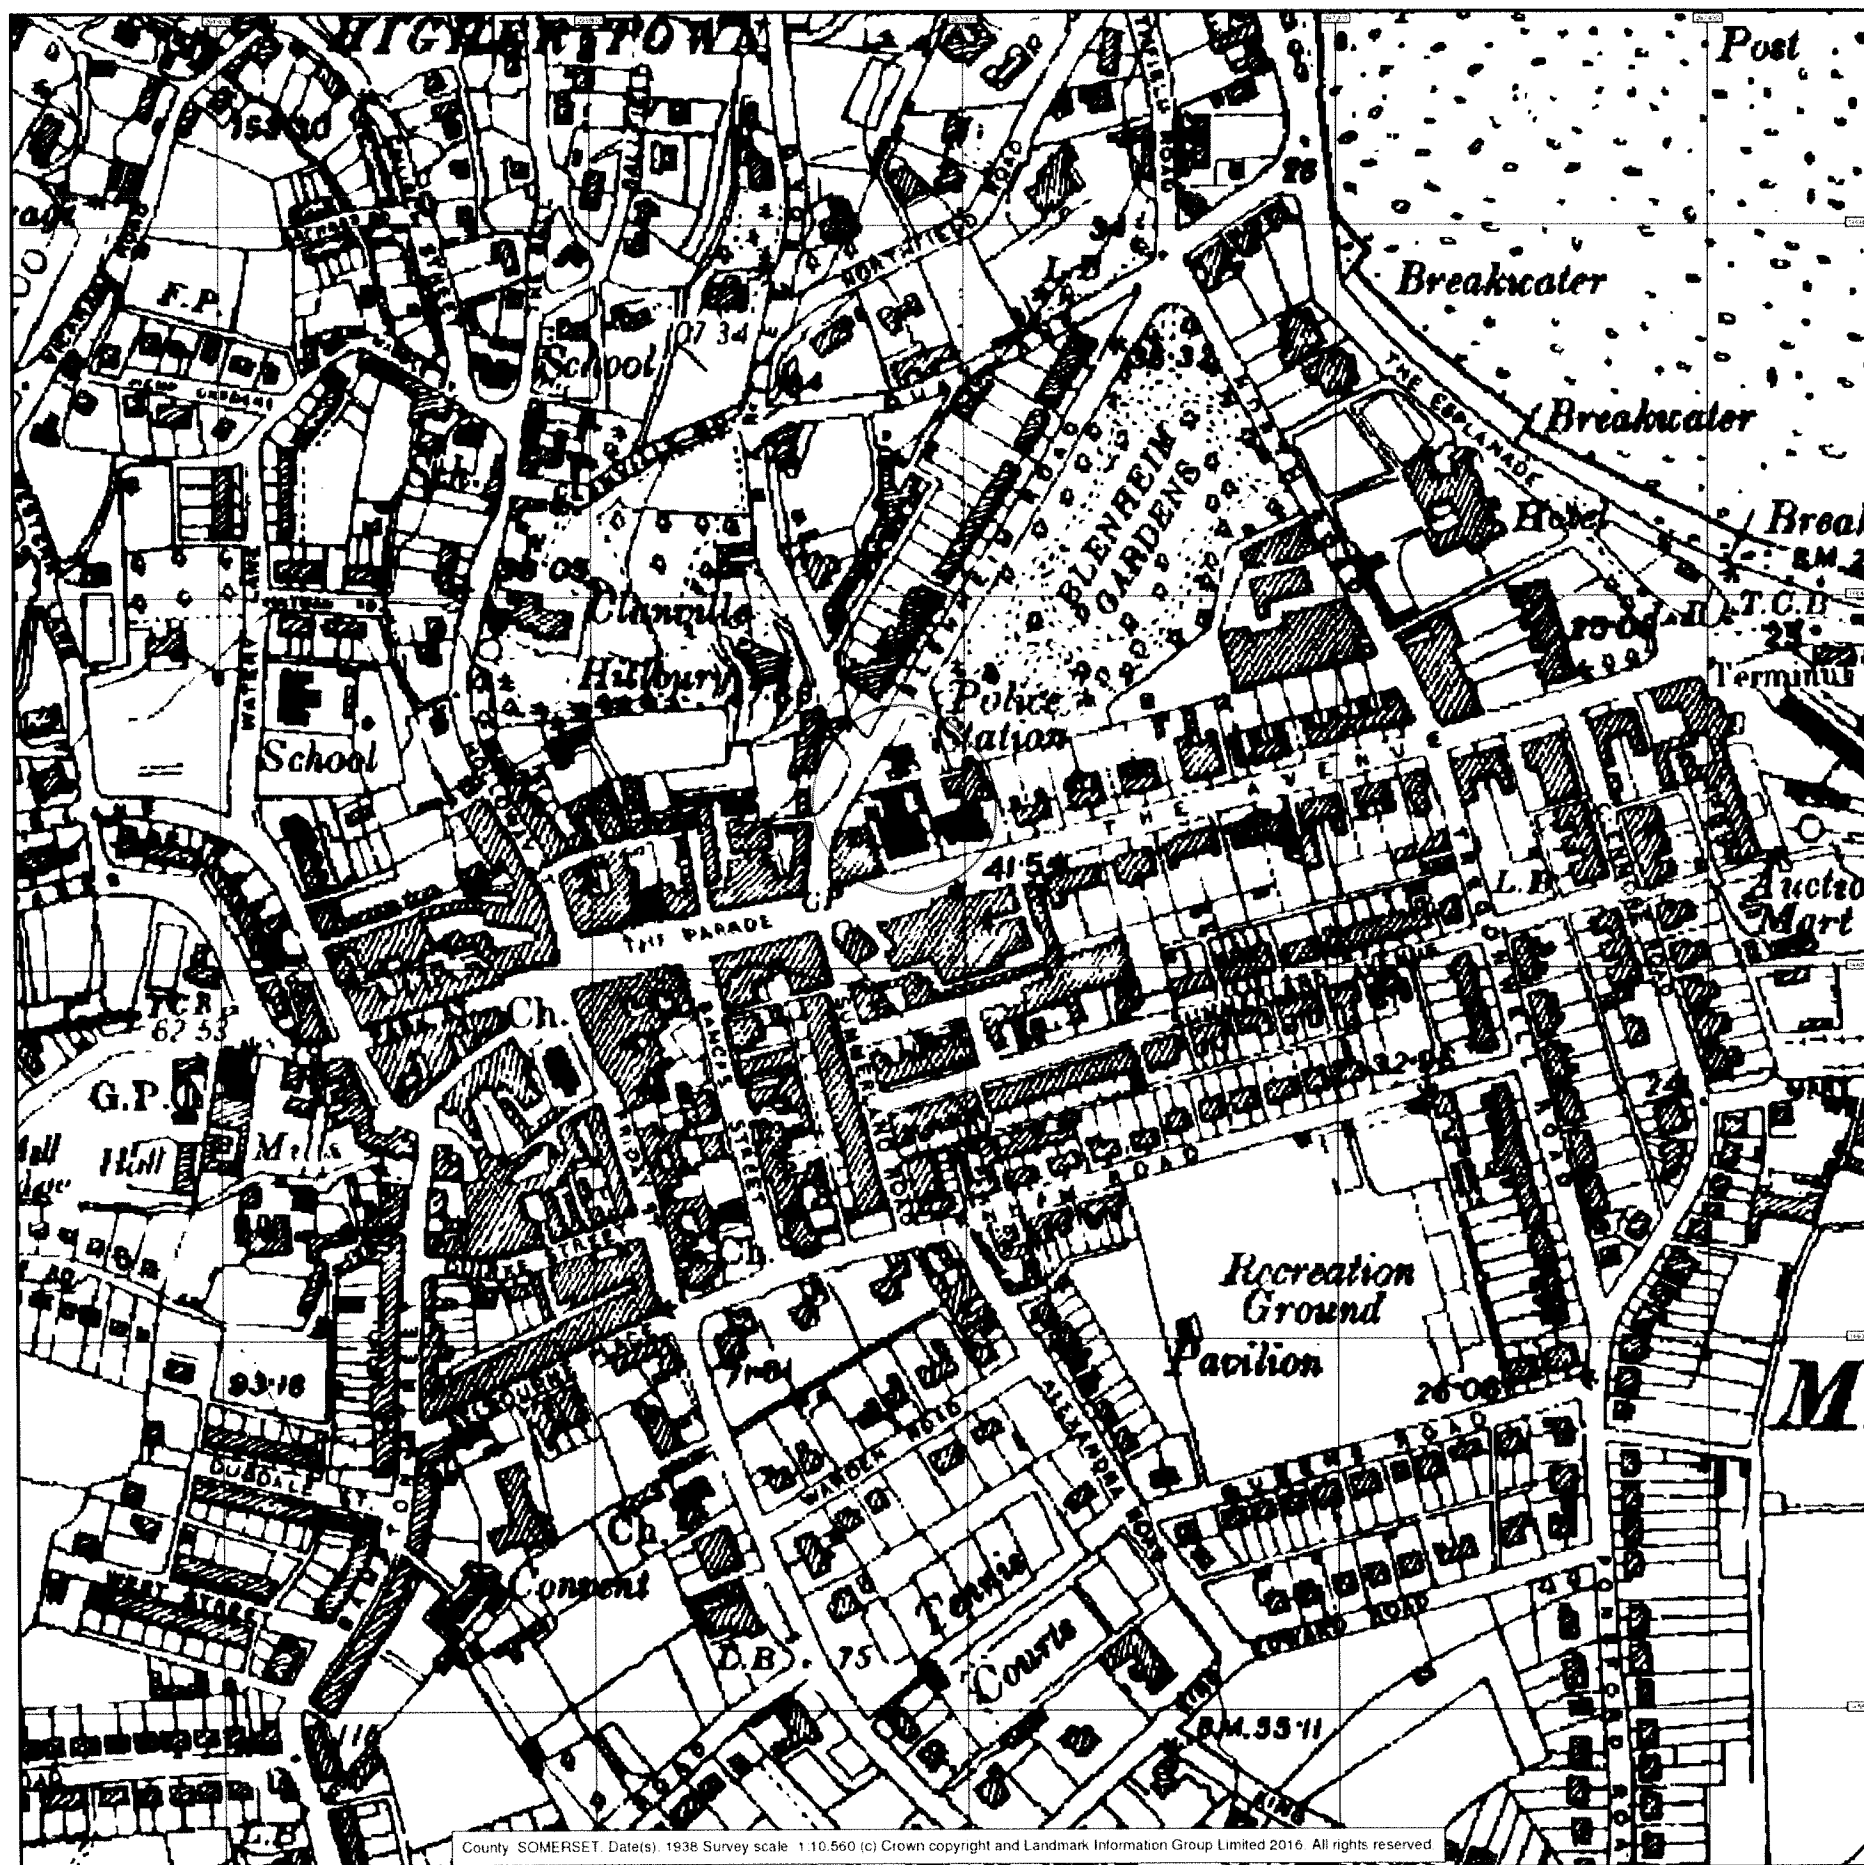
County: SOMERSET. Date(s): 1938 Survey scale: 1:10,560 (c) Crown copyright and Landmark Information Group Limited 2016. All rights reserved.

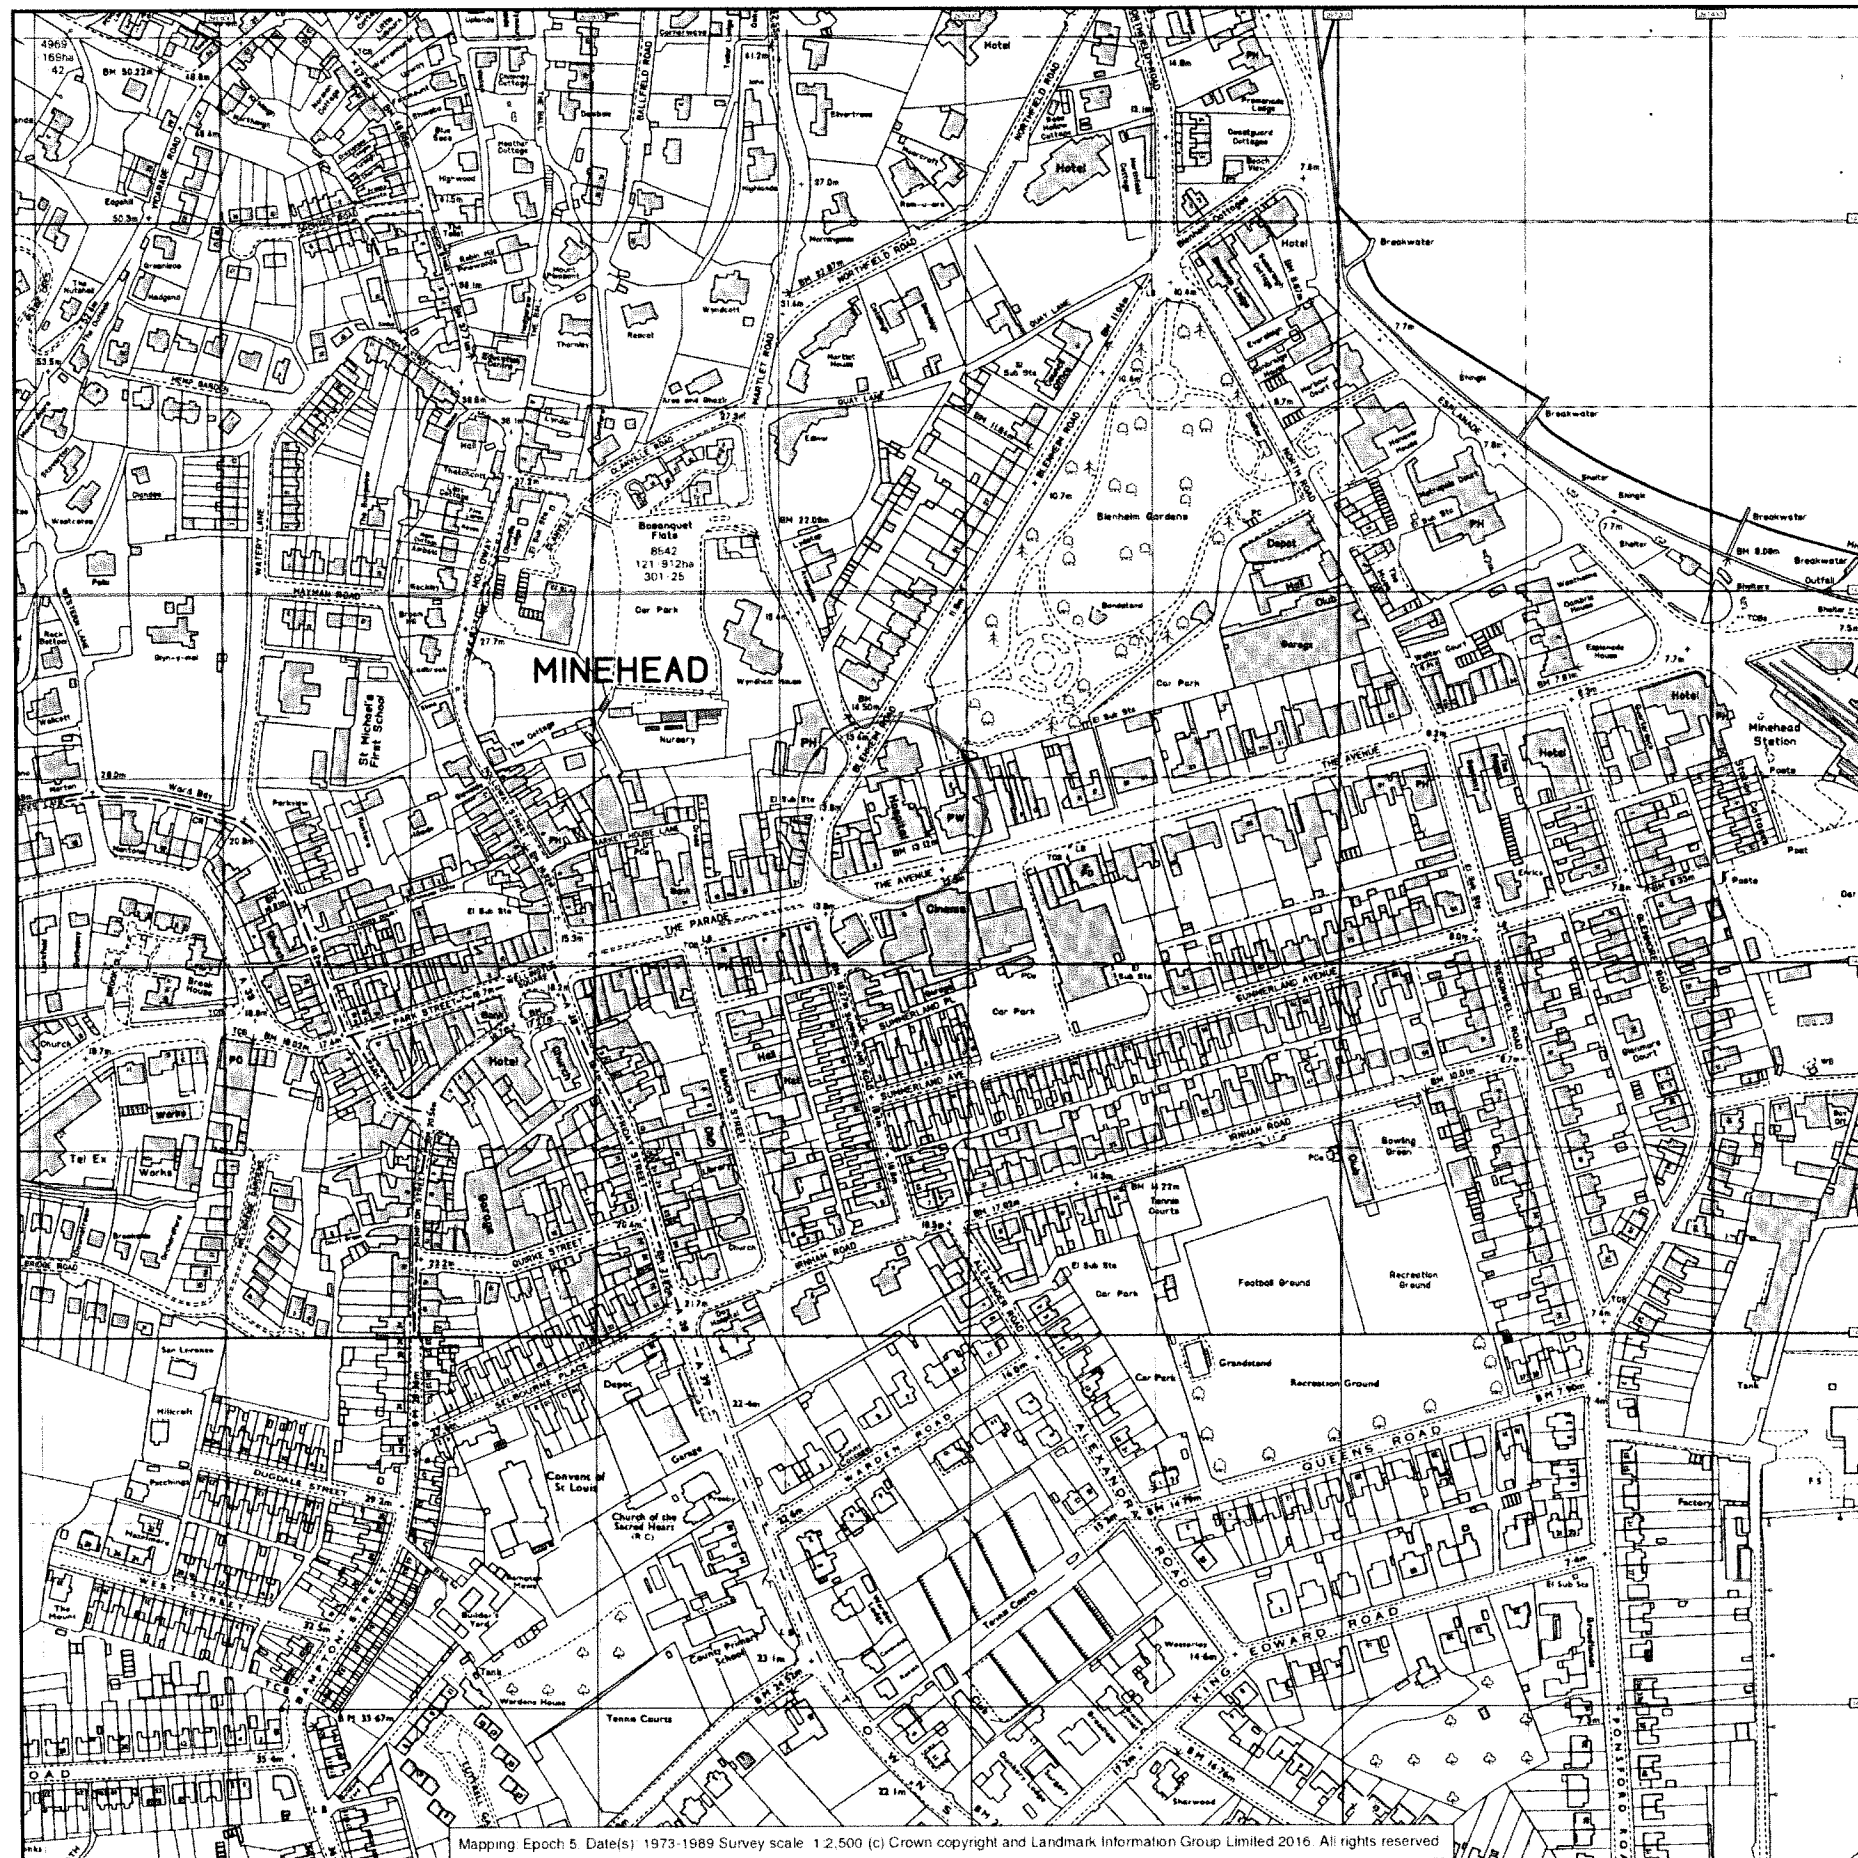
Mapping Epoch 5 Date(s) 1973-1989 Survey scale 1:2,500 (c) Crown copyright and Landmark Information Group Limited 2016. All rights reserved

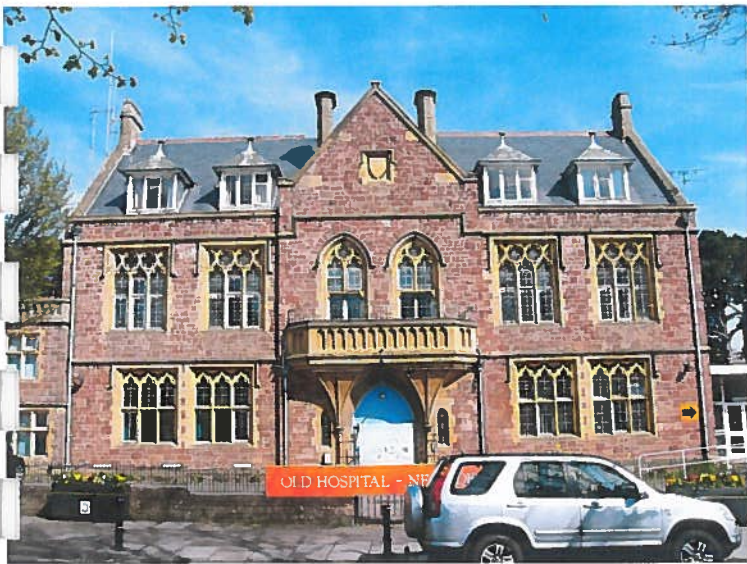
- b) Principal building centre, two storey 5 bay, squared and coursed local stone with quoins. Centre 2 bay set forward with coped gable, stone balcony on fan vault support. Main paired entrance door centre. Slate pitched roof with coped gables ashlar stone chimneys to gable apex. Fenestration, leaded light set in stone mullion and tracery surrounds. All 1888-89. Pair ashlar chimneys centre, 4 hipped slated dormers, in two pairs each side of centre gable set behind parapet, leaded light casement windows c1910. Later modification to some dormer and main windows to plain casement – mid late C20th. Original finials to centre gable base lost.

01 Main front 1888 elevation.JPG

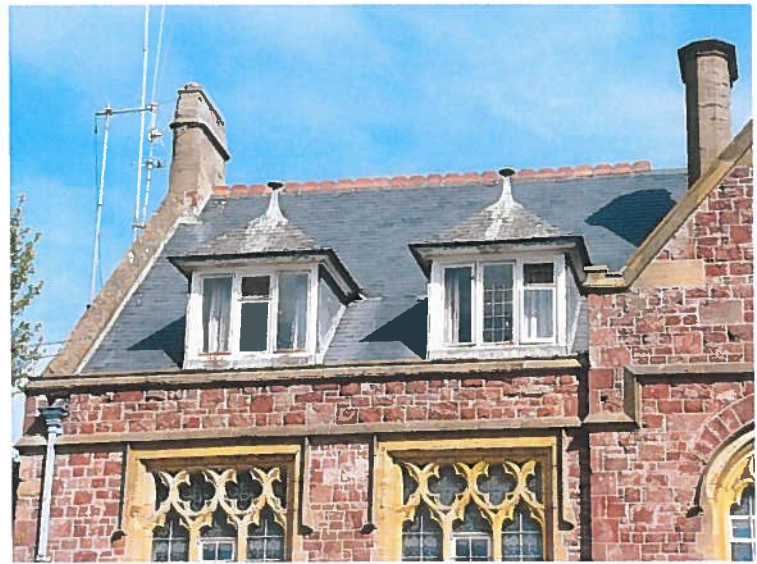
02 1910 front west dormers.JPG

- h) The reinstatement of the lost main stairs and entrance arch to the first floor hall, is also considered a positive enhancement and compliments the full reinstatement of building as originally intended.
- i) The removal of the front dormer window and central chimneys, while a loss of historic fabric from an earlier phase, is considered necessary if the original hall is to be re-instated to its original use for the community. A detailed survey and photographic record is recommended prior to their removal and the details lodged with the Records Office.
- j) The ground floor 1910 alterations should be retained to provide an administrative function spaces to avoid the loss of the ceilings and cornicing of this phase subdividing the spaces, as it is not possible to identify which cornice detail is clearly of 1888 or 1910 origin.

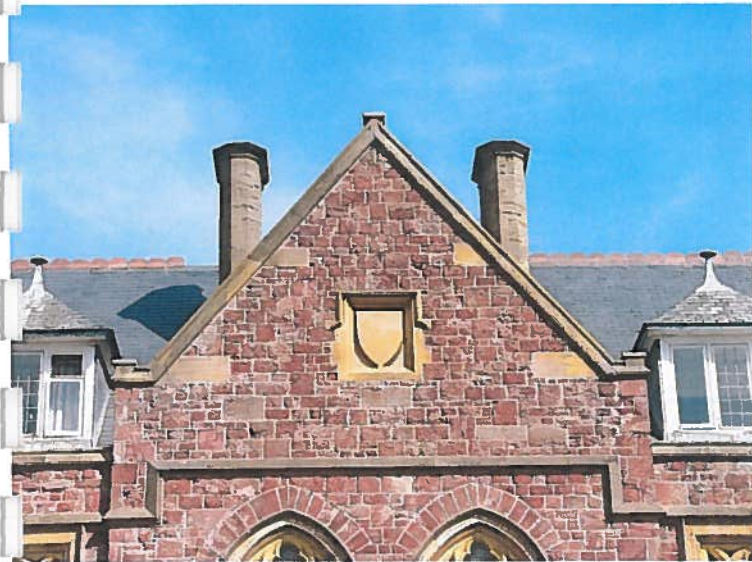
03 1888 front centre gable.JPG

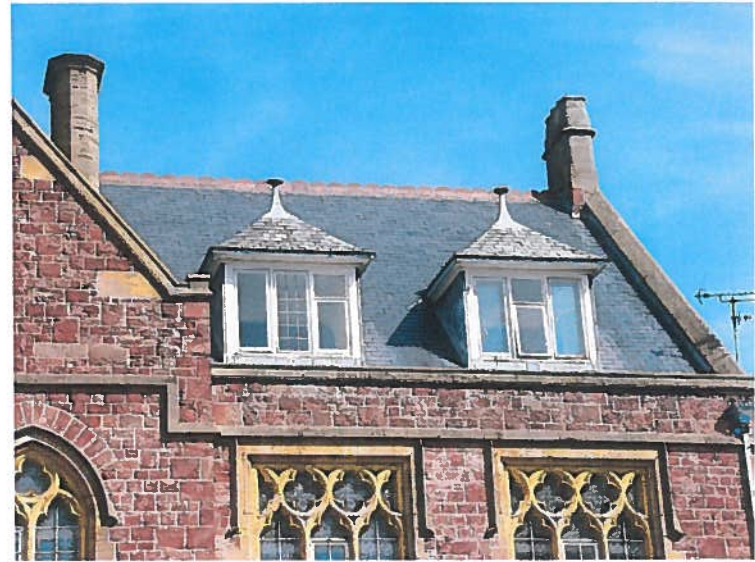
04 1910 front east dormers.JPG

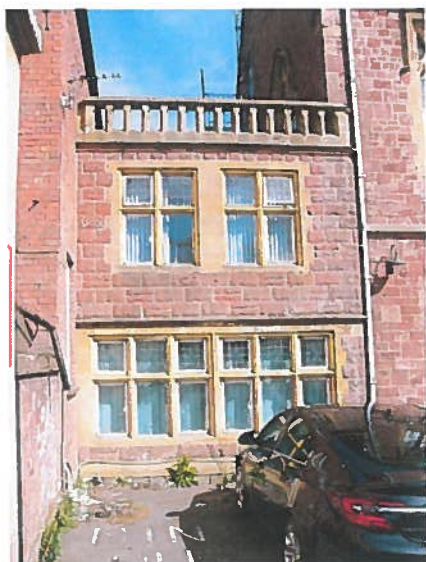
- c) Two storey infill east of main building – square and coursed local stone with ashlar string and plinth course. Flat roof behind freestone parapet and chamfered balustrade. Freestone cruciform mullion windows, lead light glazed fanlights, plain metal casement below. All c1934

05 1934 front west infill section.JPG

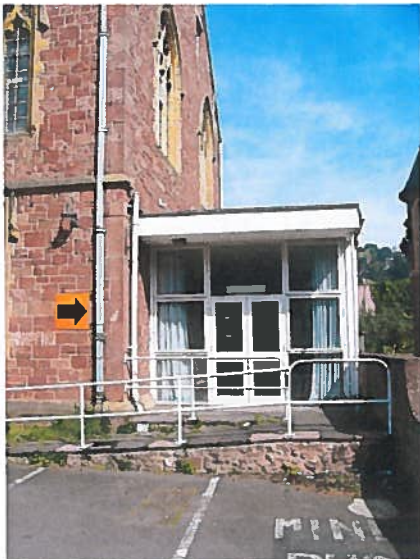
07 c1973 east front extension.JPG

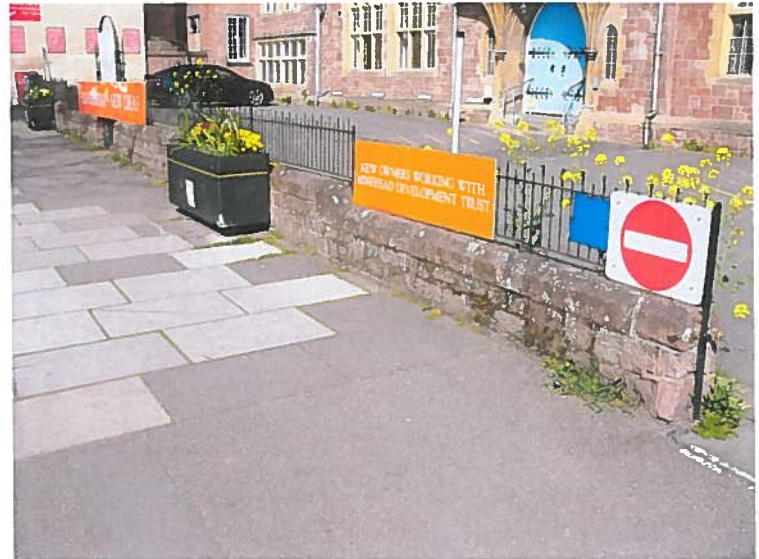
- a) Low stone wall, railing and pedestrian gate fronting site 1888, entrance gates lost. West boundary wall reconstructed stone late C20<sup>th</sup>, though 1888 stone pier retained.

08 1888 front wall and railings.JPG

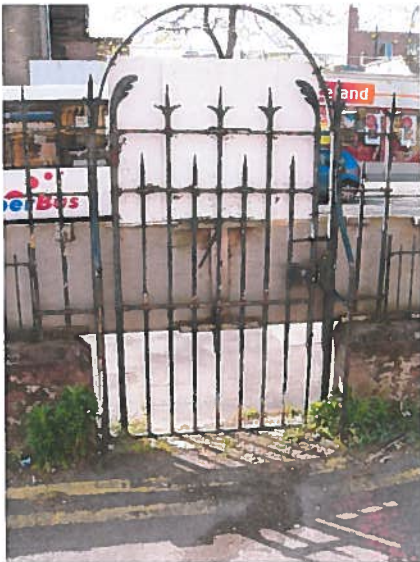
09 1888 front gate.JPG

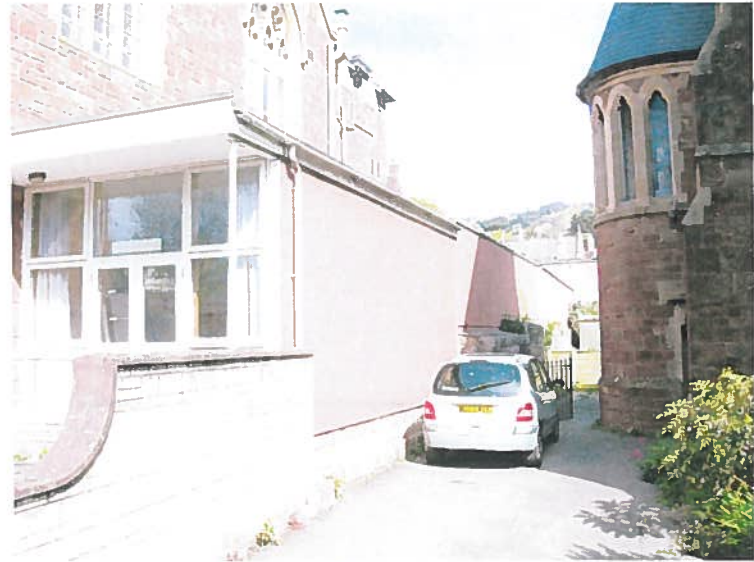
10 East side boundary.JPG

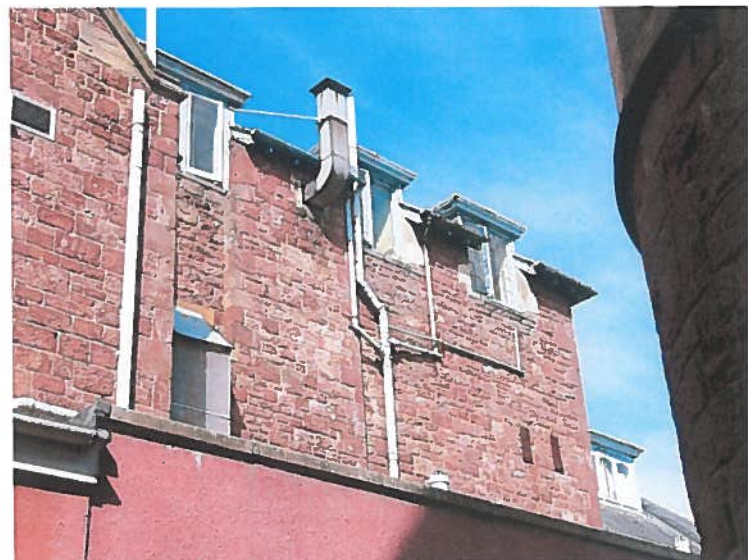
- b) Rear range three storey structure of coursed and squared local stone, chimney breast set forward. 3 timber dormers with lead covered flat roofs at eaves level, pitch slate roof. Lower section and chimney 1888, rear upper section, dormers and roof 1919. Simple plain window openings inserted first floor with replacement upvc inserts Mid/Late 20<sup>th</sup>. Original dormer window joinery replaced with large plain glazing panels late C20<sup>th</sup>. Stainless steel boiler flue attached to chimney, late C20<sup>th</sup>. Two storey tower with hipped slate roof 1888, altered fenestration Mid/late C20<sup>th</sup>.

12 1919 Second floor addition east side.JPG

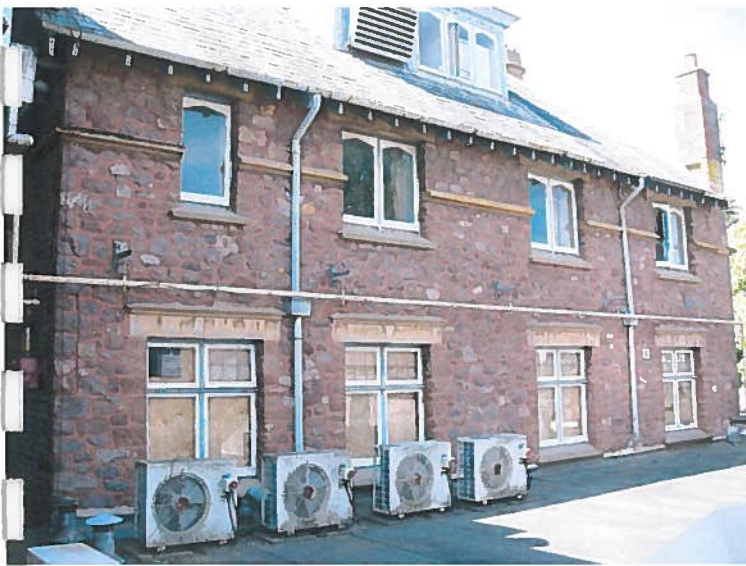
- c) Former nurse's accommodation – three storey building of local stone rubble stone, slated hipped roof with large attic room dormer, brick chimney right, ashlar stone chimney to centre of roof. Cast iron rainwater goods on exposed rafters. Four bay, 2 light cruciform timber windows to ground and first floor, 2 light casement windows to second floor, mixture of leaded light and plain glazing. 1923, with later glazing changes. Date stone at ground level, 1923.

13 East elevation 1923 Nurse's accommodation.JPG

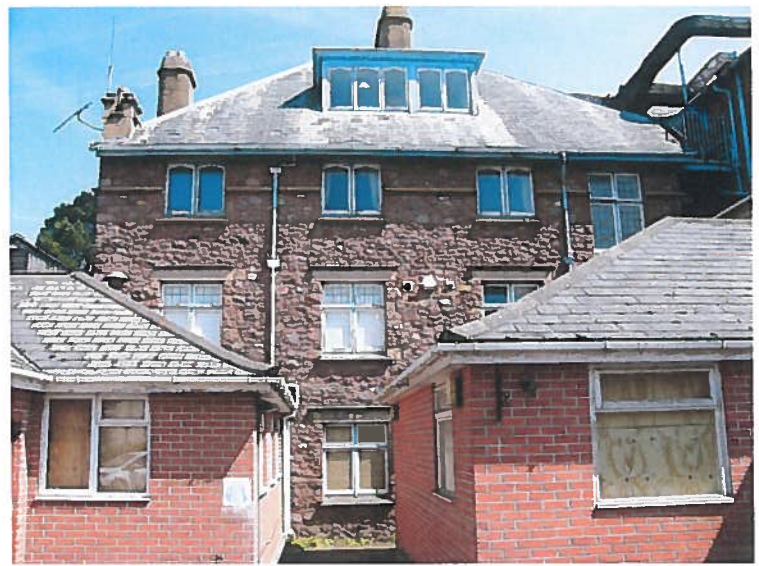
- c) Former nurse's accommodation – three storey building of local stone rubble stone, slated hipped roof with large attic room dormer, brick chimney right corner, ashlar stone chimney to centre of roof. Cast iron rainwater goods on exposed rafters. Four bay, 2 light cruciform timber windows to first floor, 2 light casement windows to second floor, mixture of leaded light and plain glazing. 1923, with later glazing changes. Ground floor obscured by late C20th flat roof addition.

14 West elevataion 1923 nurse's accommodation.JPG

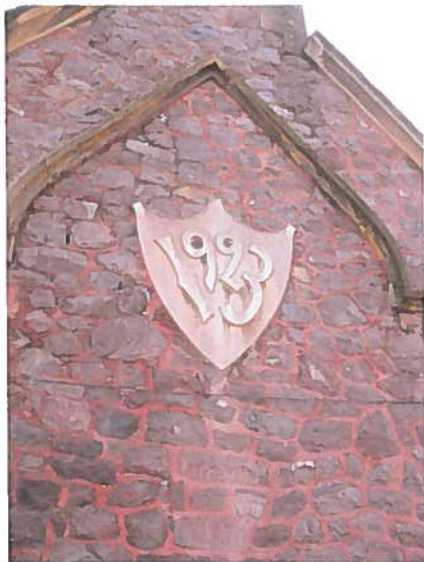
15 date shield on north wall of nurse's building.JPG

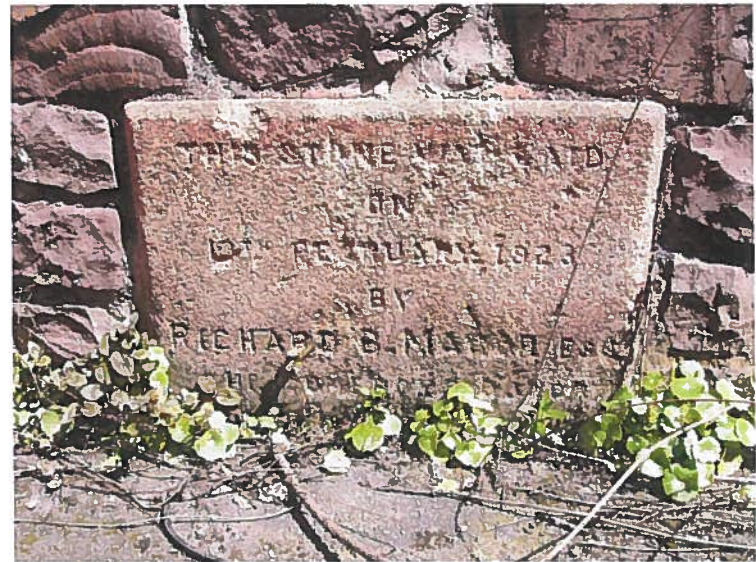
16 1923 foundation stone west wall nurse's building.JPG

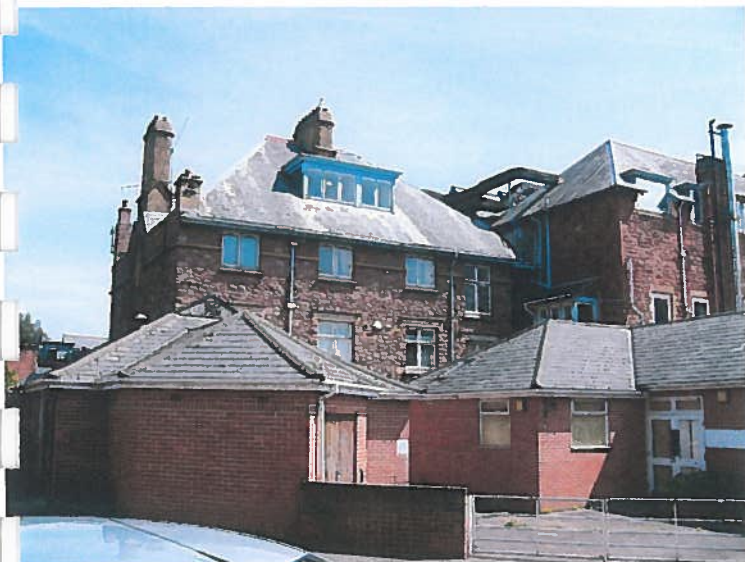
17 General view from Bleheim Road (northwest).JPG

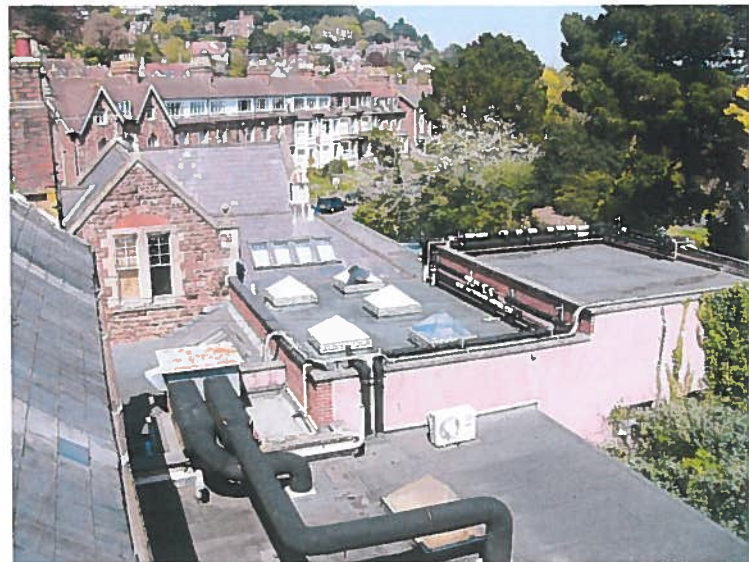
18 View looking north east from rear of 1888 building to form...

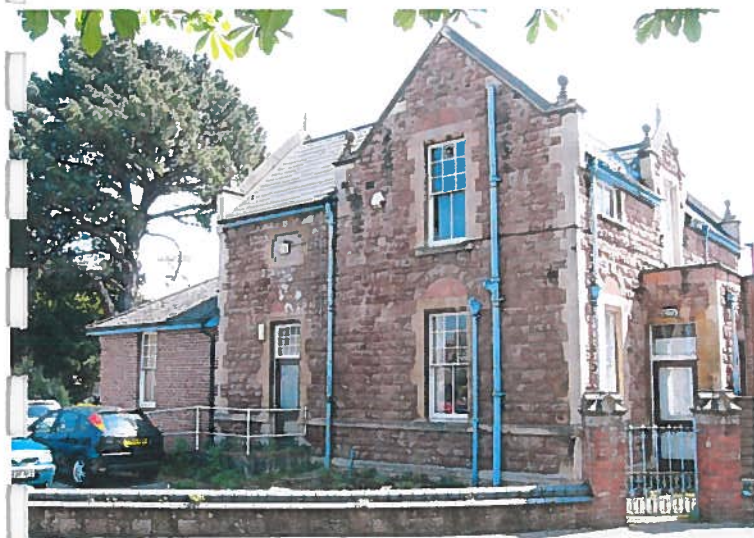
- a) Front north Blenheim Road façade – Two storey, squared and coursed local stone walls with bath stone quoins, opening surrounds and plinth band, coped gable right with finials on shoulders. Pitched slate roof, cast iron rainwater goods. 9 over 2 timber sash windows, all 1897. Single storey extensions left (west) mixture of slate hipped and flat roofs behind parapets. Brick and rendered walls – late C20<sup>th</sup>.

19. Blenheim Road view of former 1897 Police Station.JPG

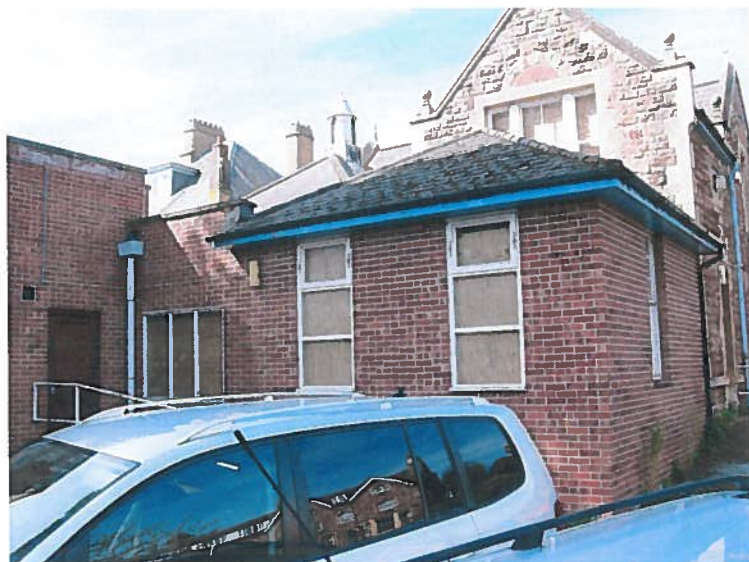
- c) East Side elevation - squared and coursed local stone walls with bath stone quoins, coped gable centre over window with finials on shoulders. Pitched slate roof. 3 bay, single storey centre projection for porch with flat roof behind parapet. Ground floor left, obscured by single storey Mid C20th addition. Ground floor left and centre first floor window 9 over 2 and 6 over 1 timber sash. All 1897. First floor metal casement window, left, mid C20th

20 Modern additions to 1897 Police Station east side.JPG

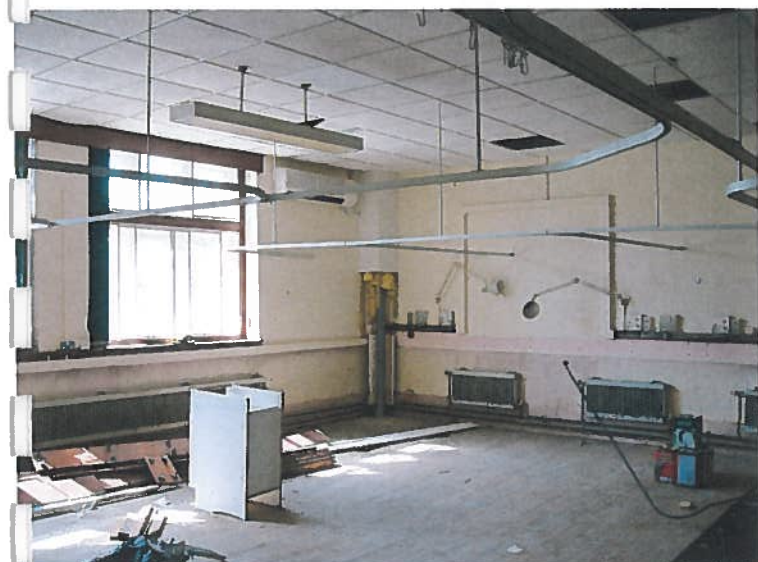
21 Former ground floor Banking Hall.JPG

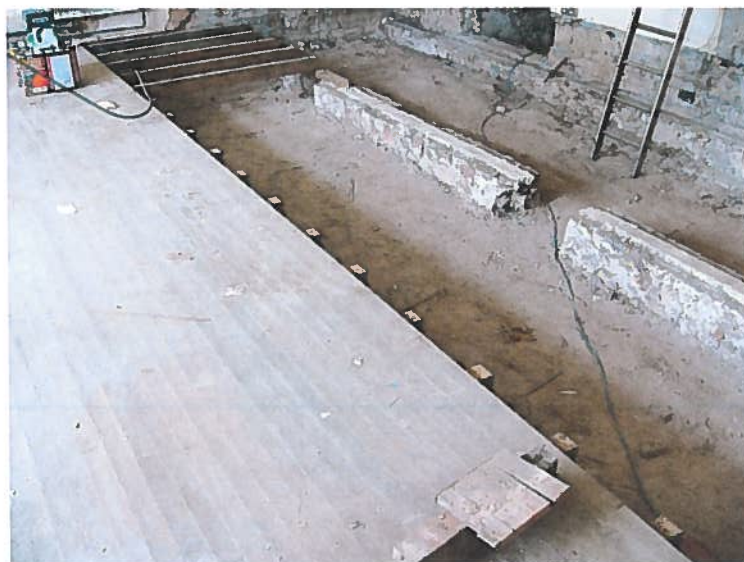
22 Former Banking Hall floor.JPG

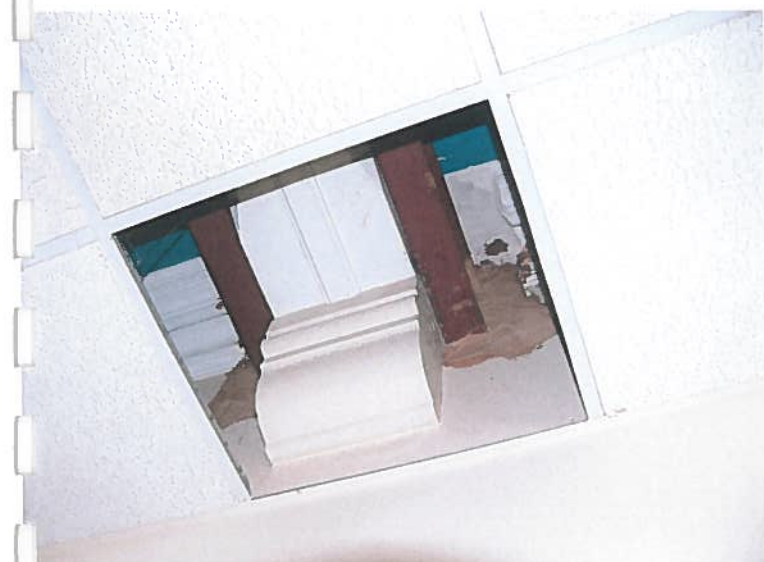
23 1888 east end first floor support beam.JPG

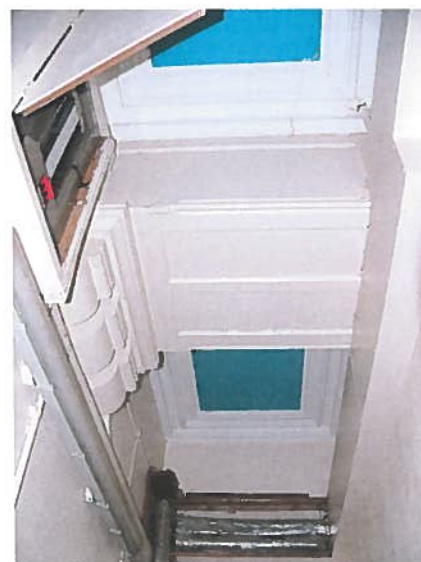
24 1888 beam with 1910 cornicing and bank vault.JPG

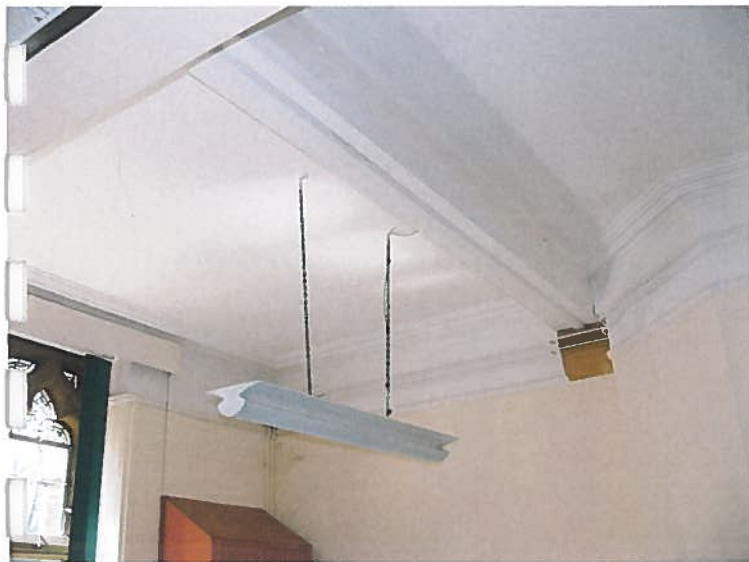
25 1888 west end first floor beam support with 1910 alteration...

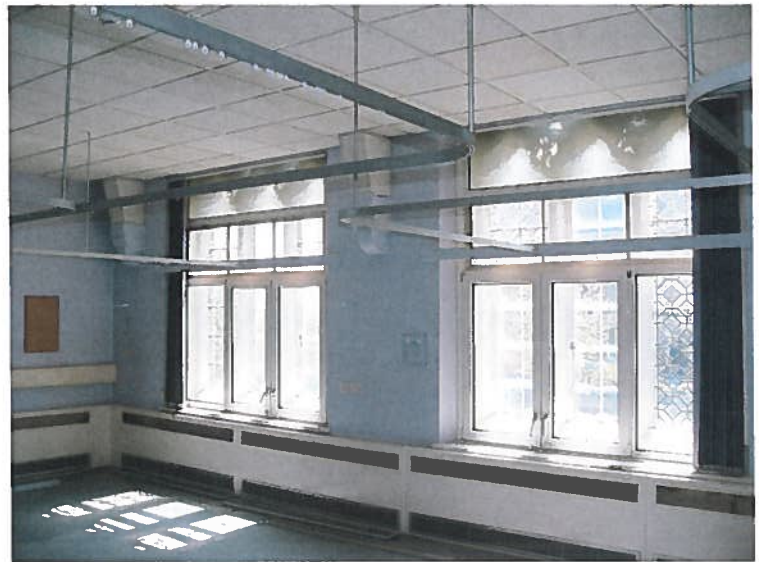
26. East end first floor former hospital ward - hammer truss ba...

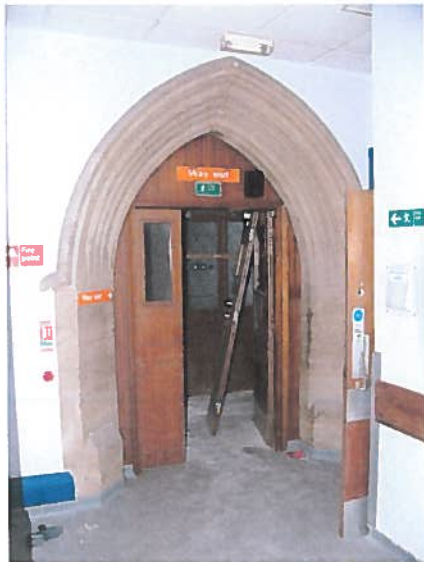
27. 1888 gothic arch to former first floor assembly room.JPG

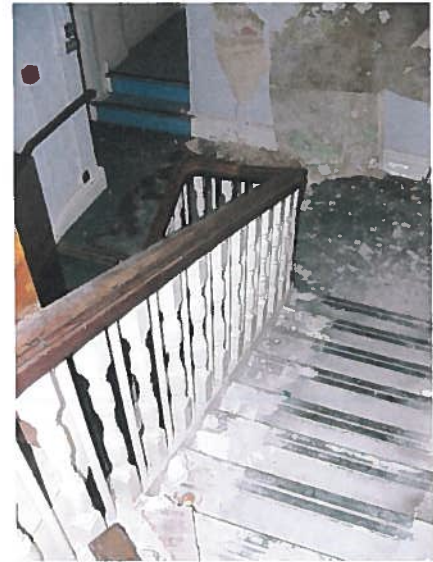
28 1888 main staircase.JPG

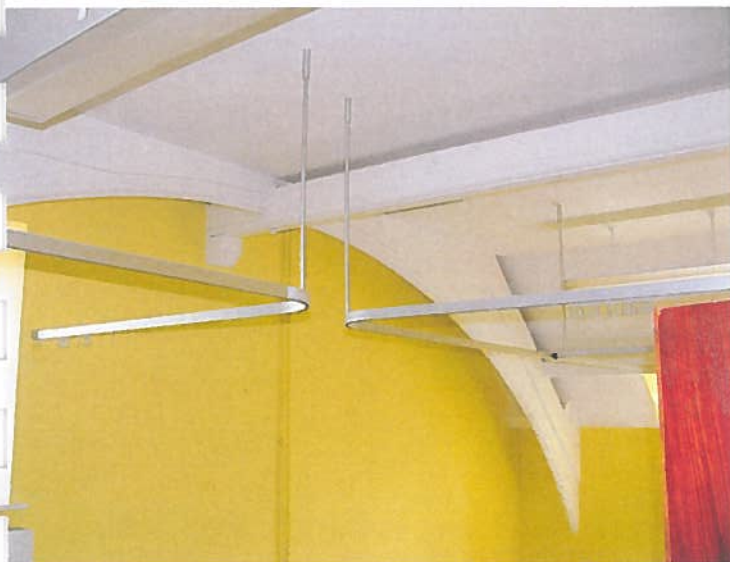
- i. Ceilings and sloping soffits – lath and plaster inserted 1910, with some later plasterboard repairs/alterations. Roof structure exposed within rooms, arched truss braces, trusses, purlins and king posts, all 1888. Rear section of roof trusses removed and supported on partitions, partly 1919 rear adaptations and post 1923 work. Trimming for dormers removing original centre purlins to front slopes and dormer insertion 1910. Rear west and east room areas 1919, centre rear room (operating theatre) c 1914 – 1918.
- ii. Walls – masonry plaster walls to end gables, 1888. Centre front chimney breast walls, east and west front room timber framed partitions, 1910. West rear range timber framed partitions largely 1919, remainder mid C20th.

29. 1888 east end arch roof bracing.JPG

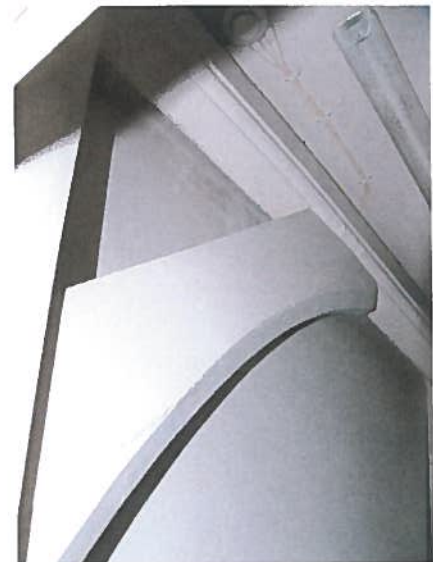
30. 1888 centre roof kingpost and brace adjacent to lift area.J...

- d) The proposals have little impact on the rear second floor area, except for the removal of the centre roof (operating theatre) for a flat roof zone for eco energy units. However, this would appear to have been part of the 1888 roof and gable structure converted out of the roof void area during WWI. The area is much altered and re-laid with poor fibre cement slate. The 1923 building behind obscures this roof structure and its modification is not seen as detrimental to the main 1888 building or impacts on the setting. The detailing of how this is to be achieved shown be conditioned.

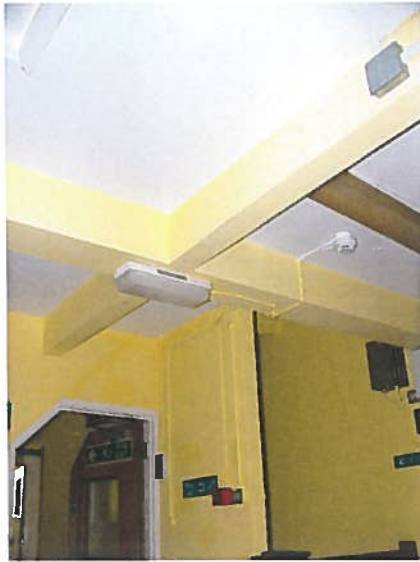
31. Post 1919 main roof support alterations adjoining lift area...

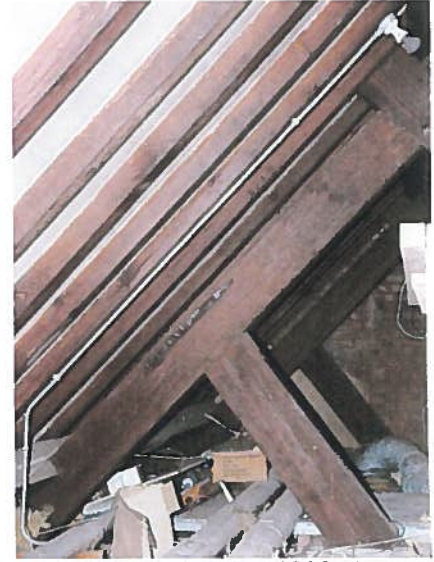
32. Roof void over second showing 1888 plaster and decorati...

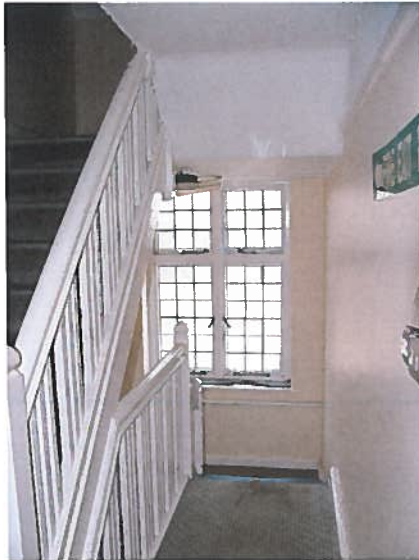
33. 1923 staircase to nurse's building.JPG

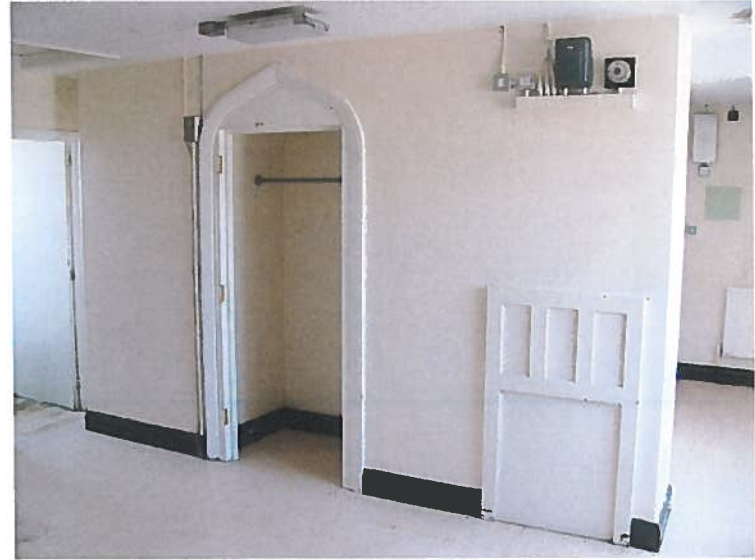
34. Attic level in 1923 nurse's building.JPG
